**ASBESTOS SURVEY REPORT
SENATE BUILDING, ROOM NO. 301
CAPITOL BUILDING
TALLAHASSEE, FLORIDA**

Prepared For
Department of Management Services
4030 Esplanade Way, Suite 380
Tallahassee Fl. 32399-0950
(850) 488 5858

Report Date: 29-Dec-06

MEI Project No: 005.046.00

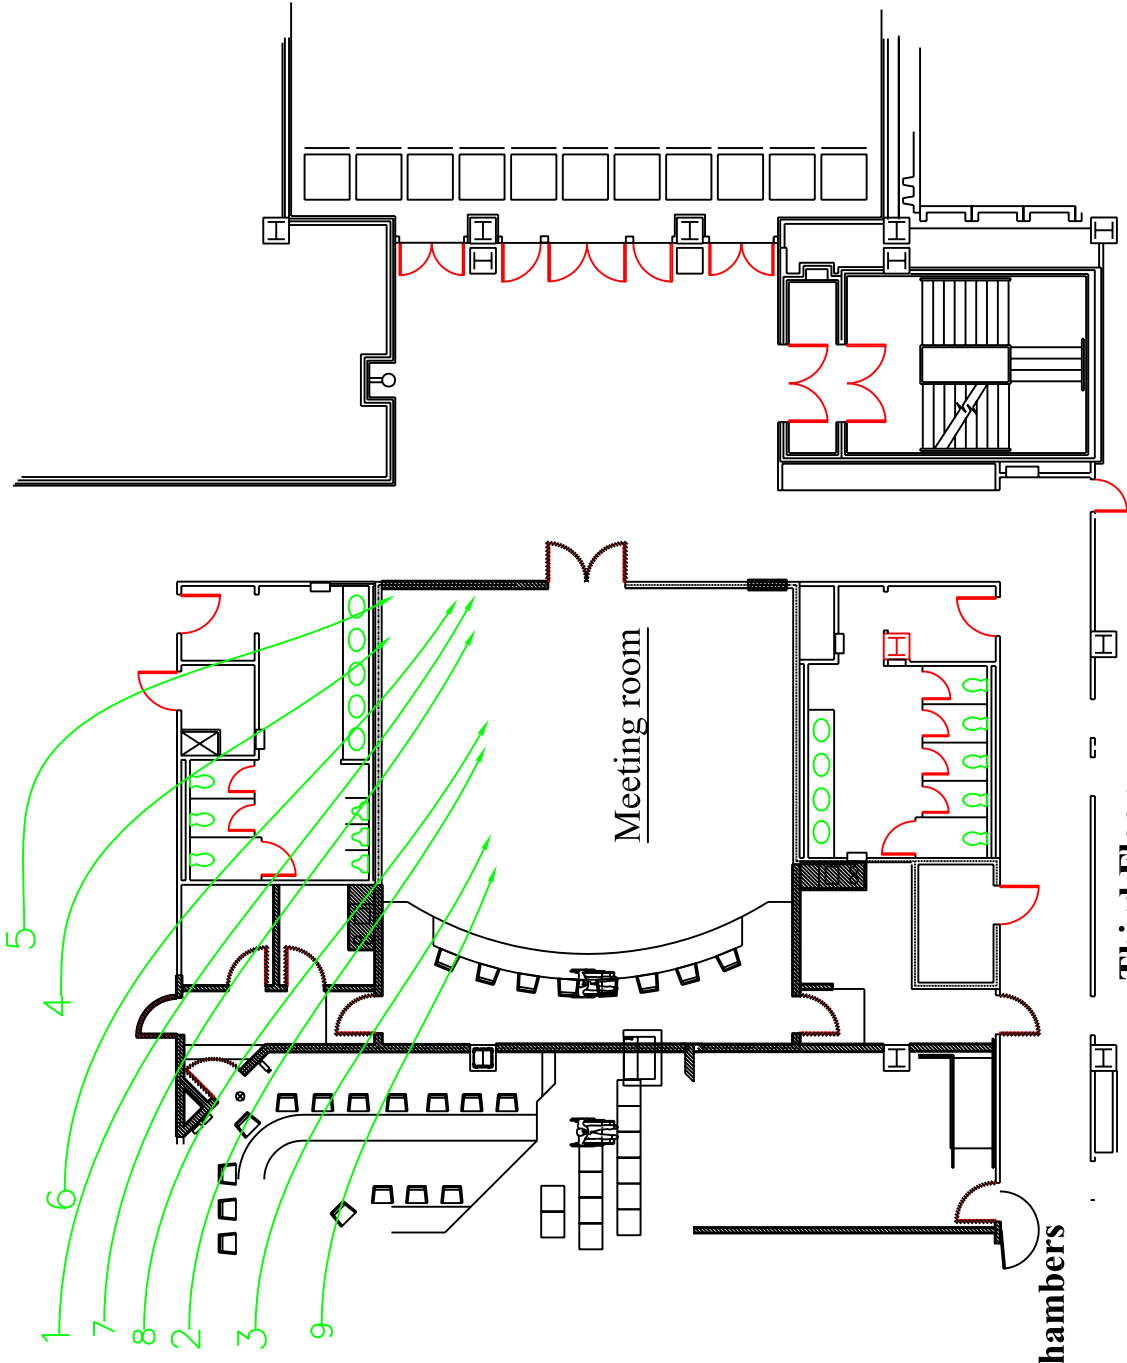
<i>Sample No.</i>	<i>HA No.</i>	<i>HA Description</i>	<i>Room</i>	<i>Result</i>
1	1	Spray applied fire proofing	Room NO. 301	NAD
2	1	Spray applied fire proofing	Room NO. 301	NAD
3	1	Spray applied fire proofing	Room NO. 301	NAD
4	2	Dry wall	Room No. 301	NAD
5	2	Dry wall	Room No. 301	NAD
6	2	Dry wall	Room No. 301	NAD
7	3	Ceiling tile 2x2	Room No. 301	NAD
8	3	Ceiling tile 2x2	Room No. 301	NAD
9	3	Ceiling tile 2x2	Room No. 301	NAD

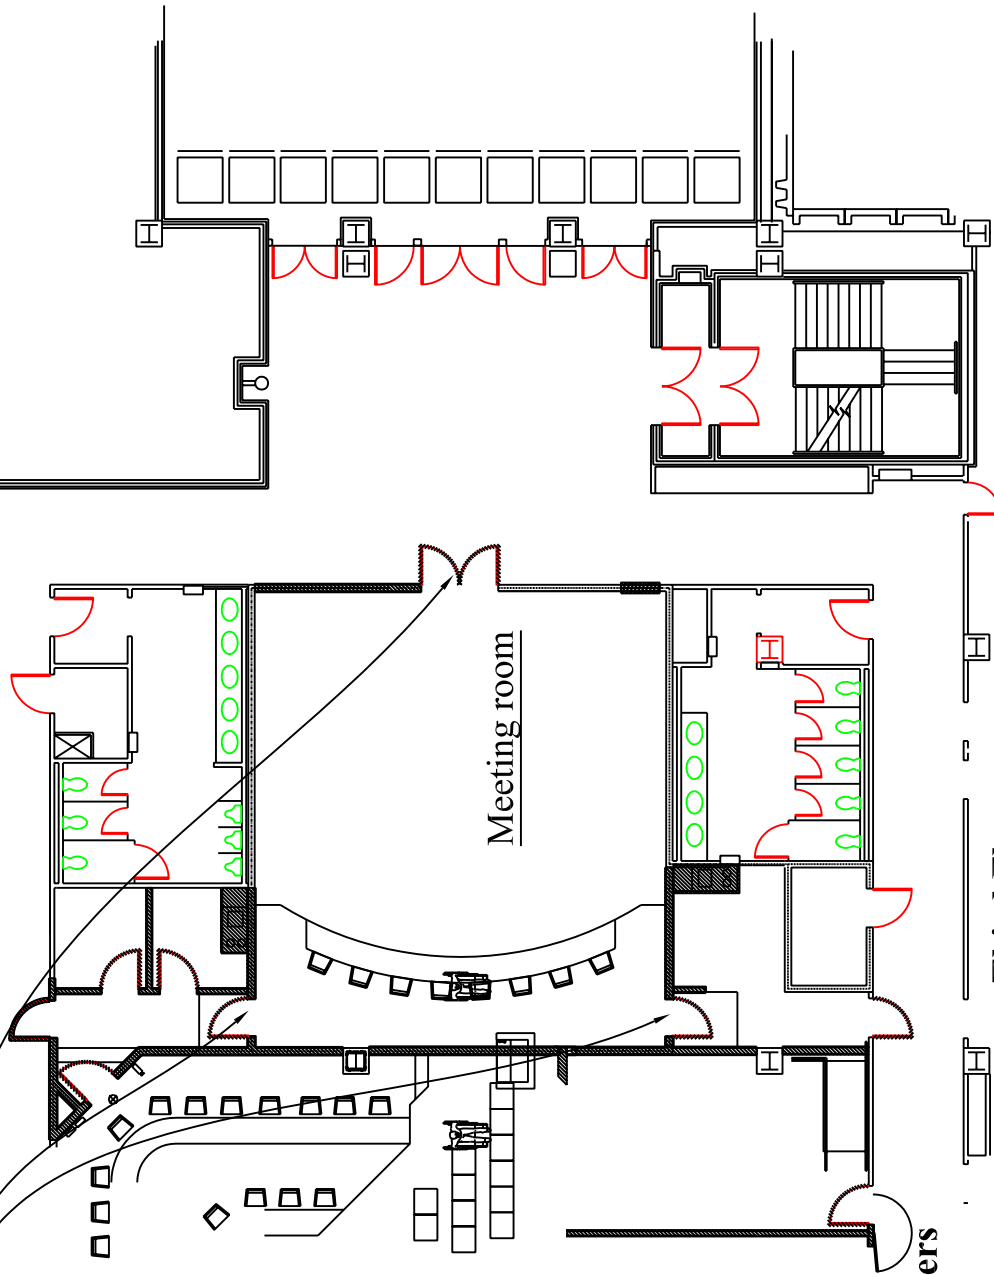
DRAWING NO.	2
PROJECT NO.	005.046.00
DRAWN BY	S.Thakkar
APPROVED BY	A.Thakkar
DATE	12/28/2006

<i>HA No.</i>	<i>HA Description</i>	<i>Friable</i>	<i>ACM Category</i>	<i>Recommendations</i>
4	Fire door	No	Category I Nonfriable	Based on prior survey information the fire doors were considered as ACM.

<i>HA No.</i>	<i>HA Description</i>	<i>Room</i>	<i>Quantity</i>	<i>Unit</i>	<i>Condition</i>
4	Fire door	Room No. 301	3	ea	Good

HA 4, Fire door is ACM

- Prior to renovation activities, all ACM that would potentially be disturbed by those activities must be removed.

- Until removal of all ACM, implement Operations and Maintenance (O&M) plan.
